**INDOOR ENVIRONMENTAL QUALITY INVESTIGATION
FOR
GLENWOOD MIDDLE SCHOOL**

**HOWARD COUNTY PUBLIC SCHOOL SYSTEM
10910 ROUTE 108
ELLICOTT CITY, MD 21043**

**ARIA ENVIRONMENTAL, INC.
PO BOX 286
WOODBINE, MD 21797**

NOVEMBER 1, 2013 ✓

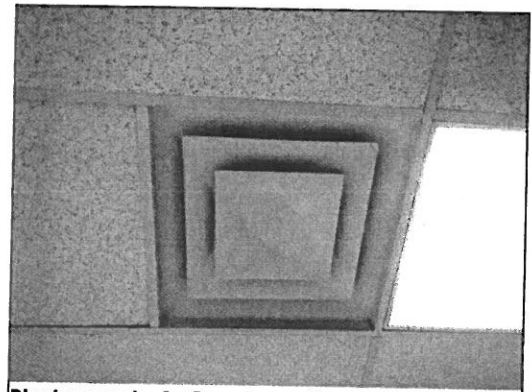
The visual inspection of the rooms visited on August 28, 2013 did not reveal any obvious sources of water damage, moisture or mold growth. Condensation was observed on supply air diffusers in the hallways and on unit ventilators operating in cooling mode. A strong musty/mildew odor was observed in the entry vestibule to classrooms 33-35 and at the boys and girls bathrooms, janitor's closet and expansion joint in the main hallway providing access to the 6th and 7th grade wings.

Photograph 1: Condensation on supply air diffuser in hallway by Boiler Room.

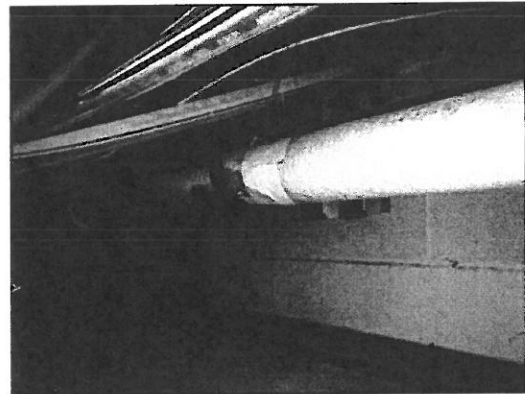
Room 26: More than 3 feet of pipe insulation is wet. Early mold colonization was observed.

Photograph 2: Room 26 pipe insulation.

Obvious mold growth was not observed in the classrooms, above suspended ceilings, on the roof, or in univents. Water stained pipe insulation with speckling consistent with early colonization of mold should be removed and replaced with new insulation in classrooms 26 and 27. Moldy odors were observed in the school building along with obvious air movement from the crawlspace into the building. Testing for fungi in the school revealed that the crawlspace is the apparent source for mold migration into the school. The transition from strong negative pressure to a slightly positive pressure will reduce this pathway for exposure. Additional recommendations for mold control are made in this report.

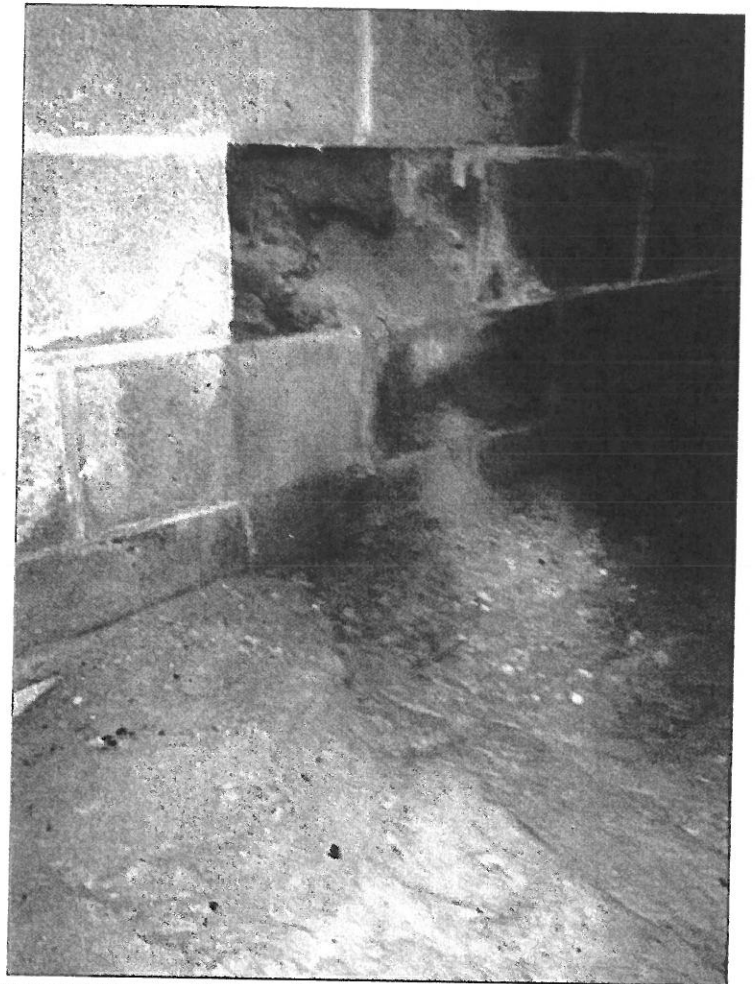
Photograph 3: Missing CMU block with signs of water migration on soil. Crawl space under main hallway between 8th Grade and 7th Grade wings.

Moisture control is necessary in the crawlspace to prevent the growth and amplification of mold. Ventilation, weatherproofing and replacement of missing or damaged concrete masonry unit block is recommended. Removal of abandoned steam pipes and associated insulation is recommended to eliminate food sources for mold growth. Soil in the crawlspace is moist where CMU is missing or where condensation has dripped onto the soil floor. The need for sealing the soil crawlspace floor should be evaluated if other moisture reducing measures fail.

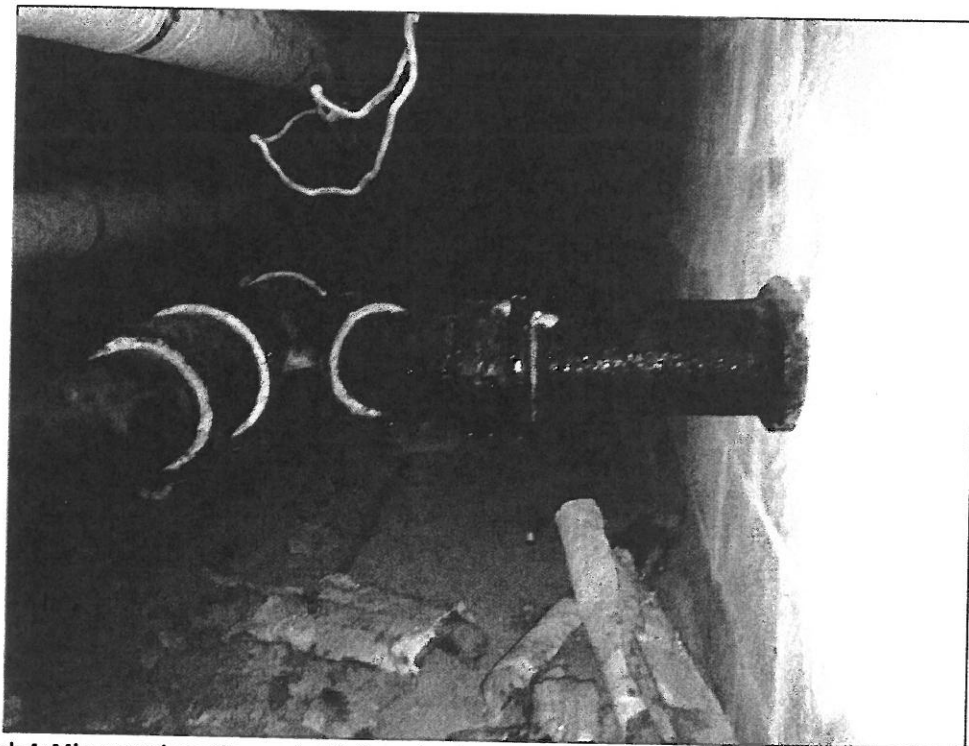
Photograph 4: Minor condensation on ductile iron pipe in main crawlspace near work room entrance to crawl space.

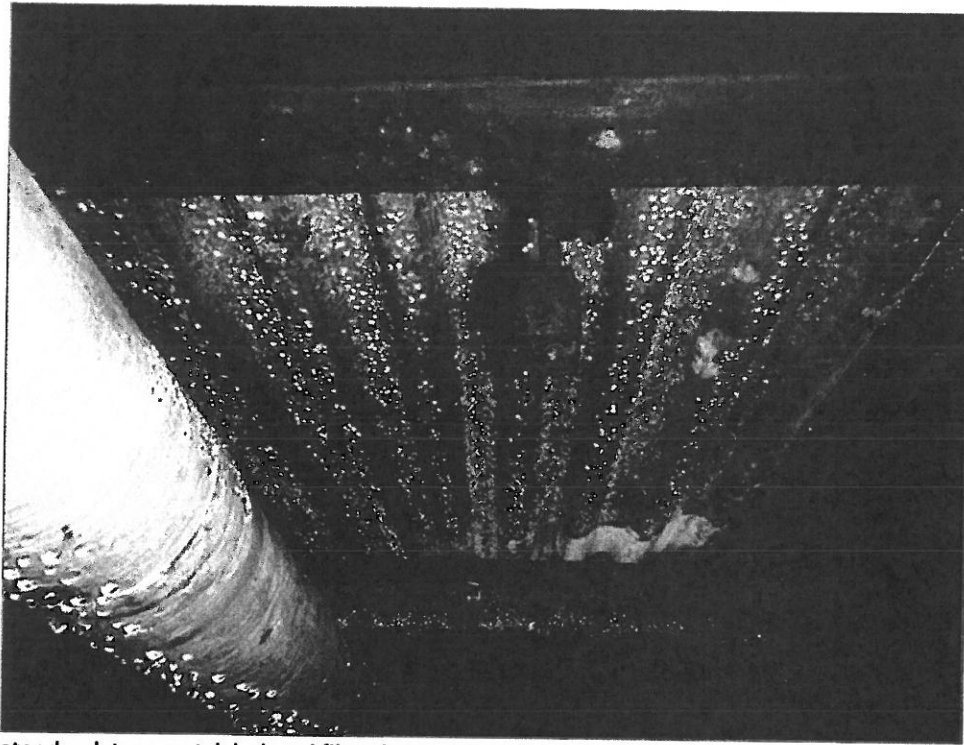
Photograph 5: Water droplets on metal deck and fiberglass insulation in crawlspace under seventh grade hall under room 27 or 29.

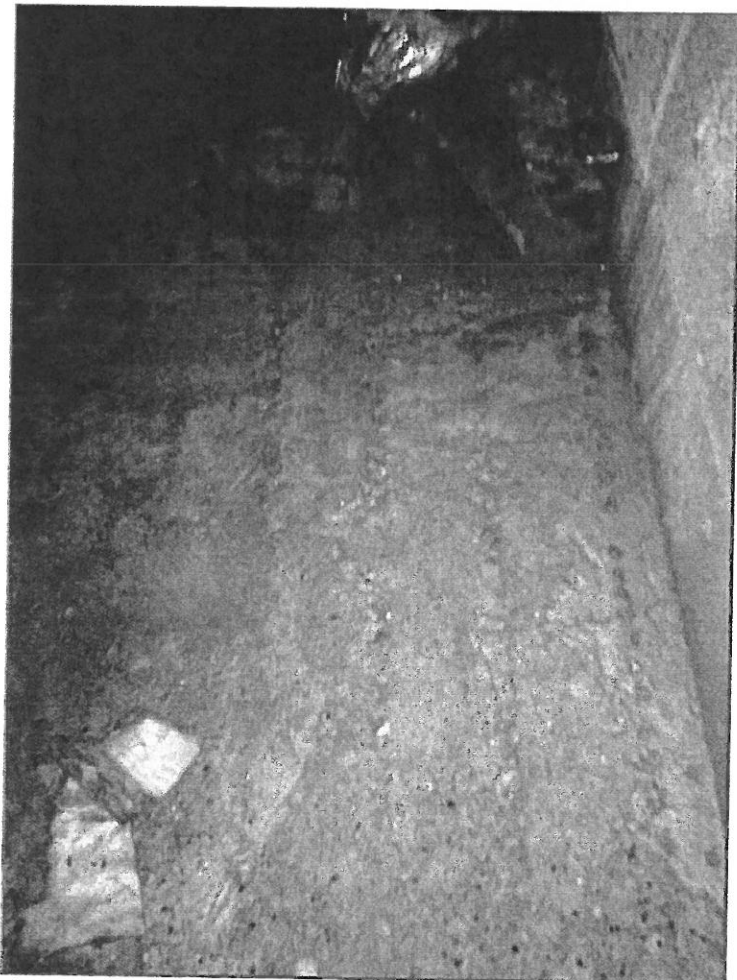
Photograph 6: Corresponding water droplet pattern on soil floor of crawlspace at location noted above.

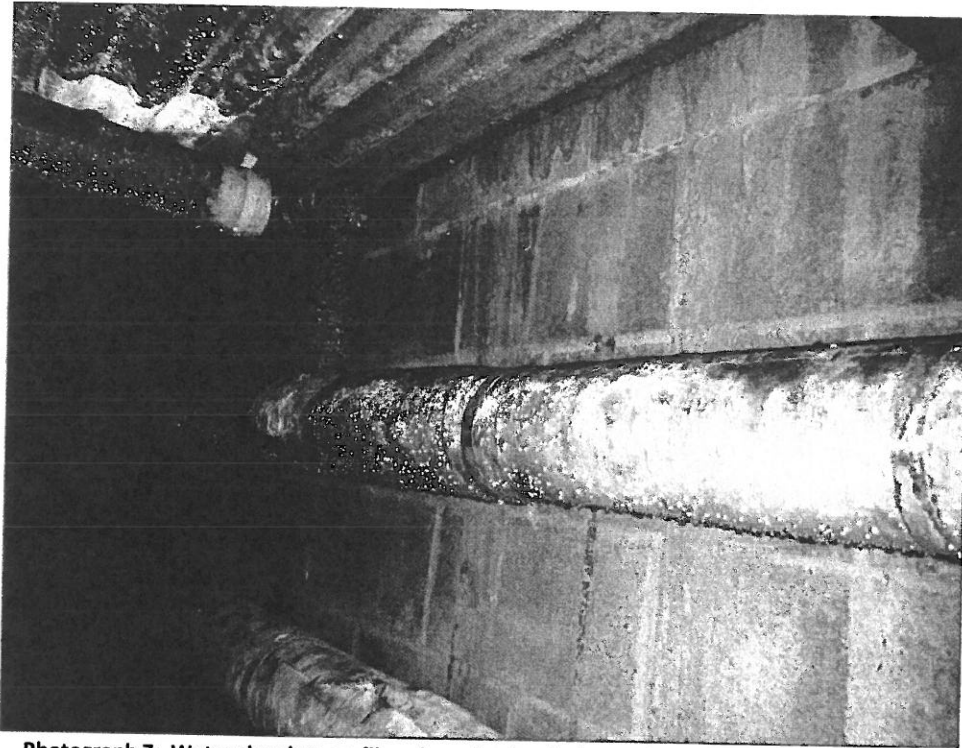
Photograph 7: Water droplets on fiberglass pipe insulation and rust on exposed metal pipe.

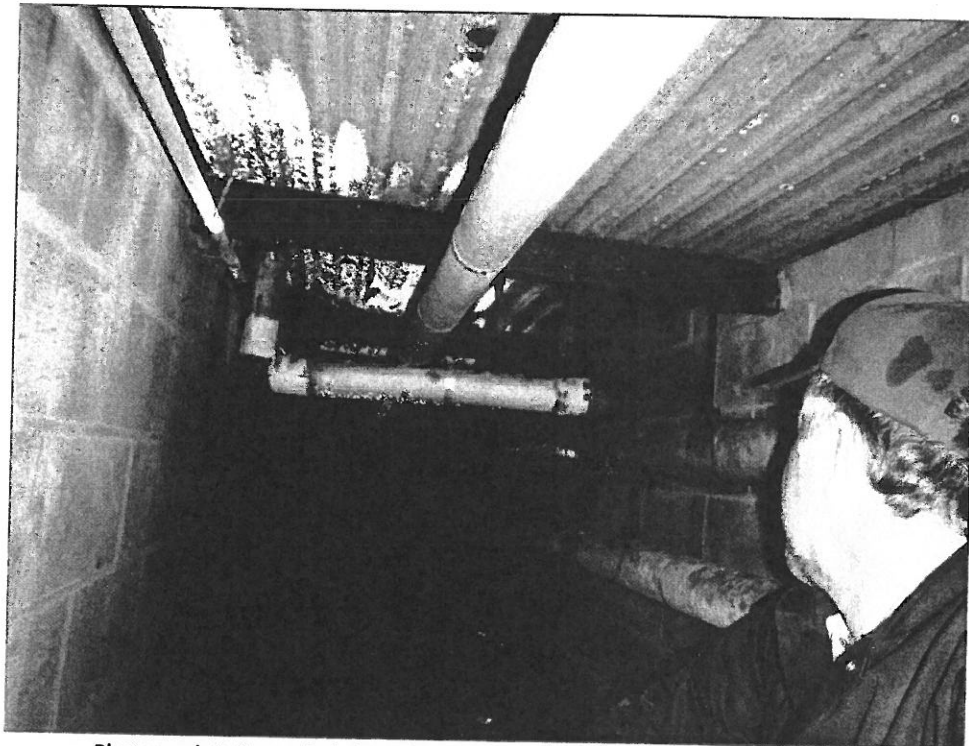
Photograph 8: Expanded view of conditions noted in Photographs 5 through 7.
Condensation on metal deck appears to be associated with unit ventilator.

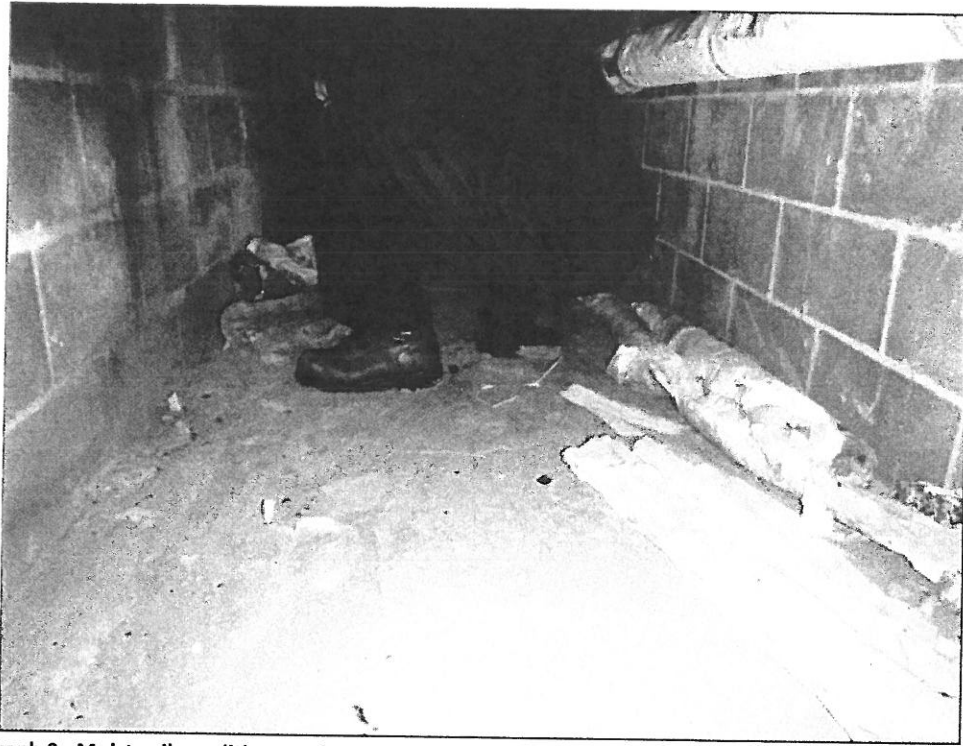
Photograph 9: Moist soil conditions and water staining on CMU wall in crawlspace under 7th grade classrooms.

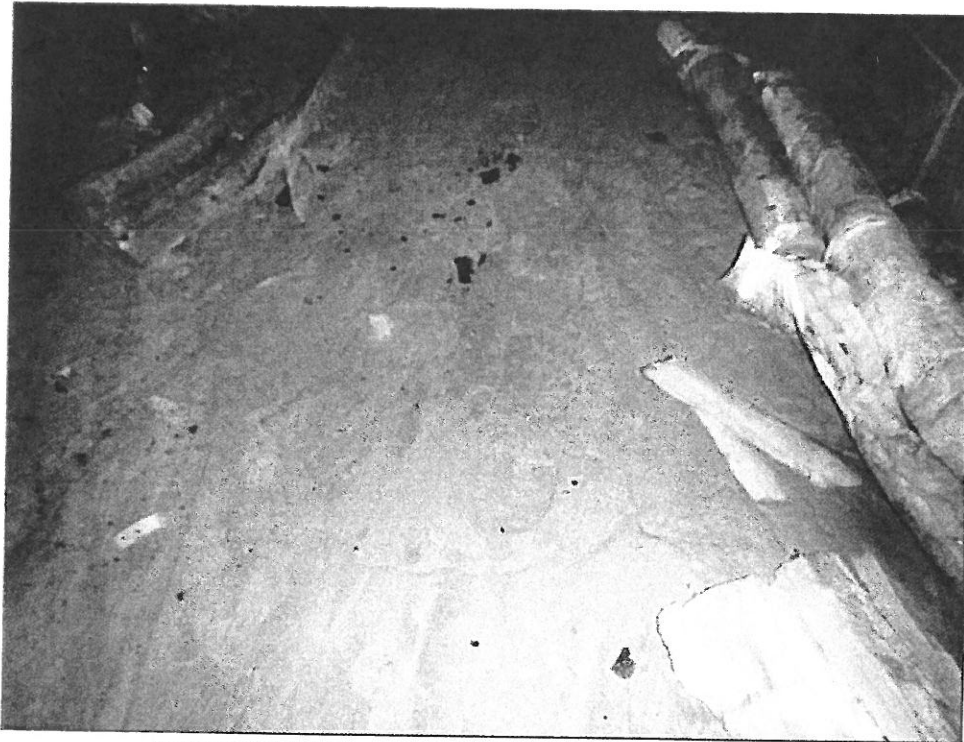
Photograph 10: Evidence of water flow across the crawl space floor.

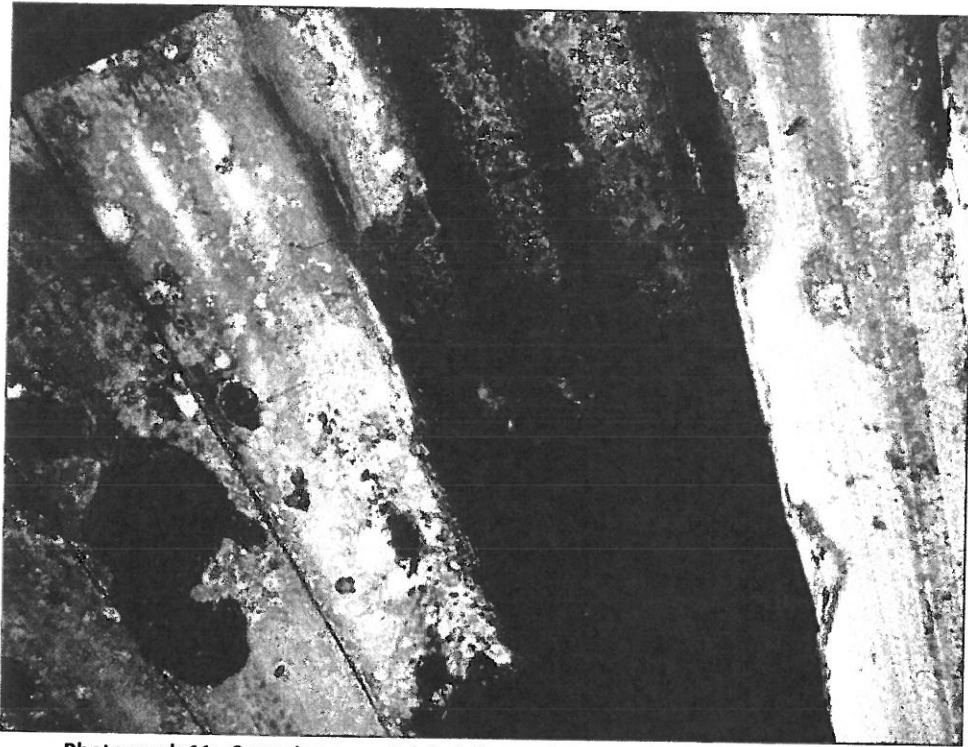
Photograph 11: Corrosion on metal deck in crawlspace under 7th grade classrooms.

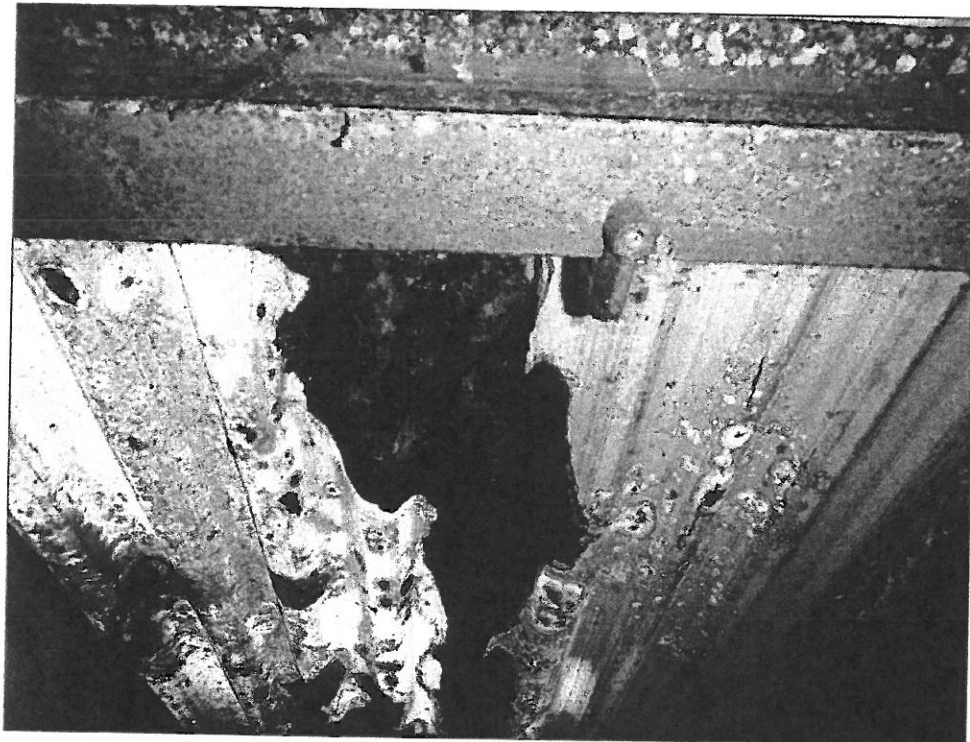
Photograph 12: Another example of corrosion on metal deck.

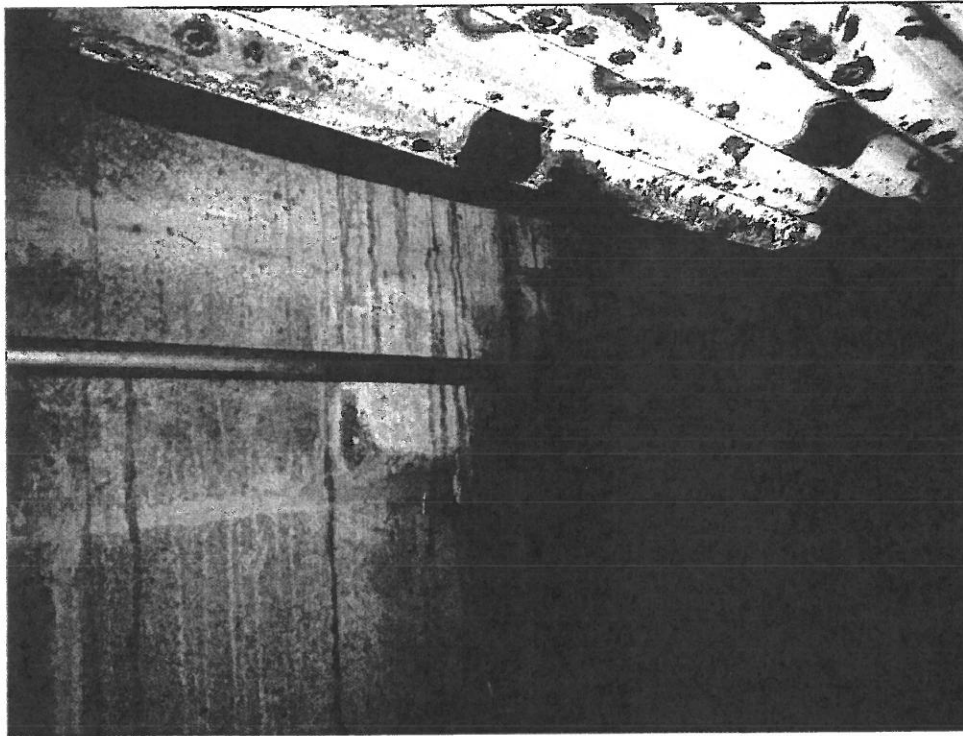
Photograph 13: Moist spot and efflorescence on CMU wall with smaller areas of corrosion on the metal deck in 6th grade crawlspace.

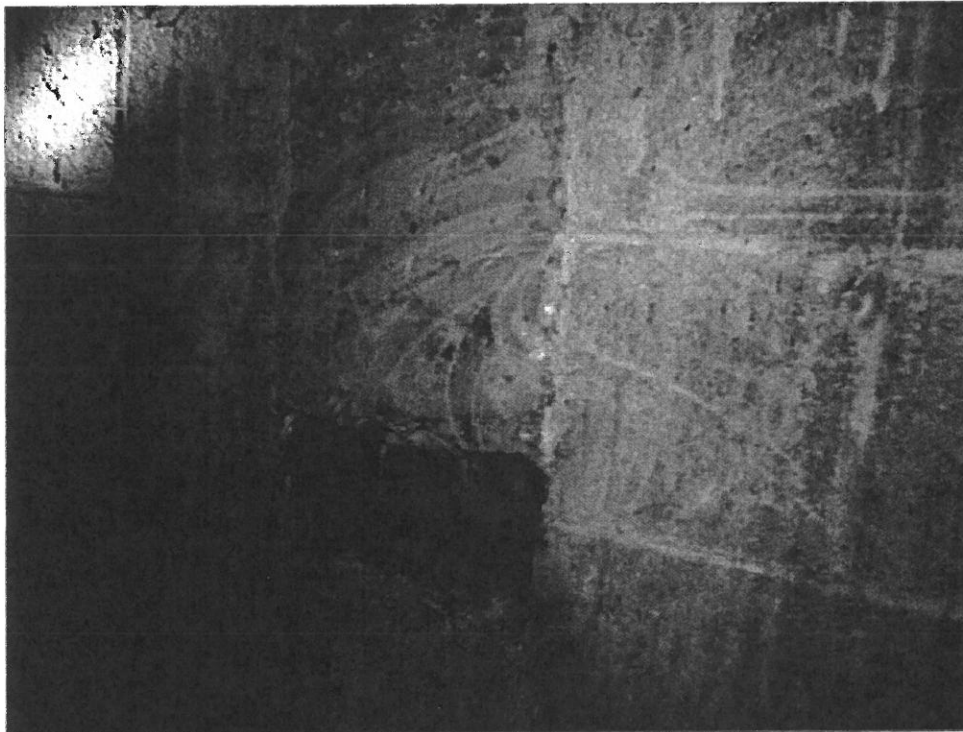
Photograph 14: Vent in 6th grade crawlspace. Vents were observed in 8th grade crawlspace but not in 7th grade crawlspace.

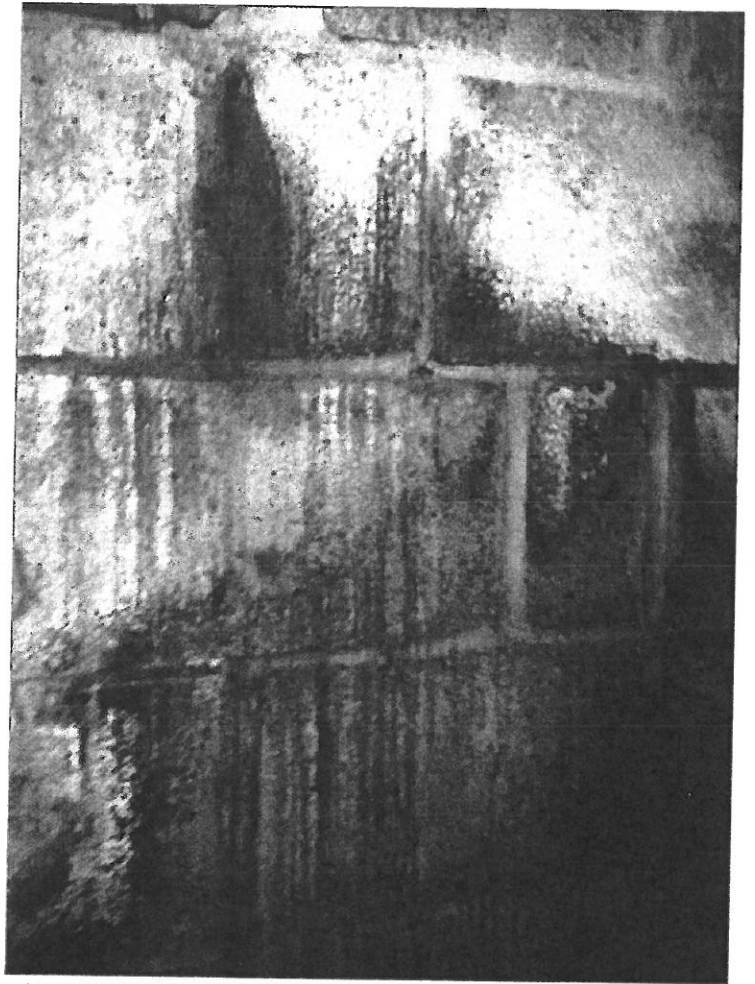
Photograph 1: Weep hole and staining on crawl space wall at corner of Room 13.

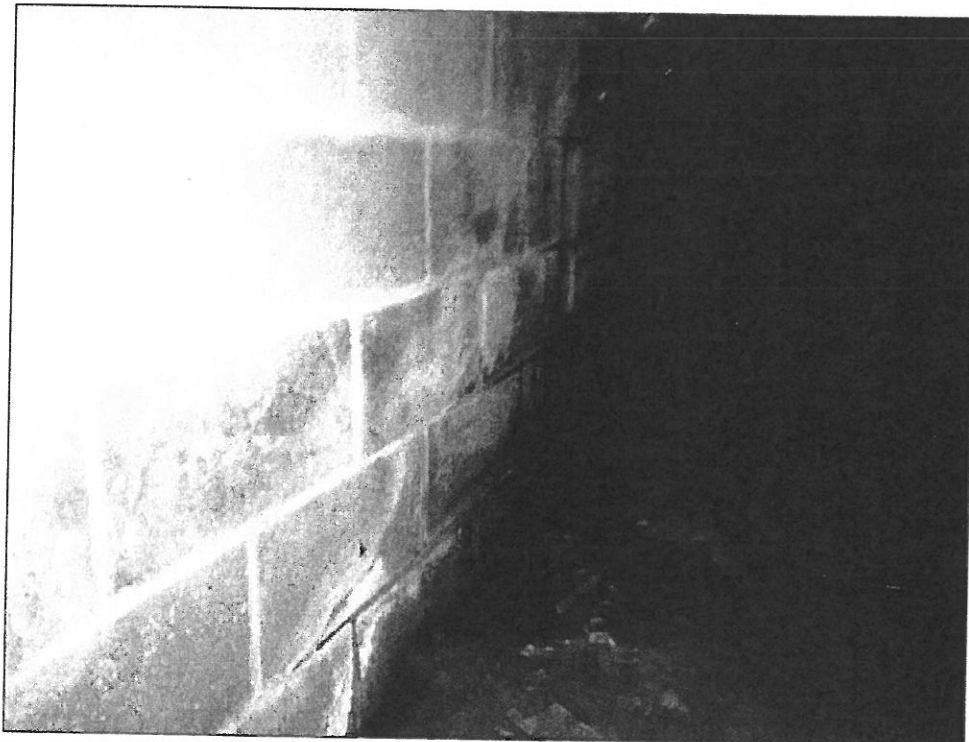
Photograph 2: Moist concrete masonry unit walls, efflorescence, and moist soil in crawl space under main corridor near intersection of crawlspace under classroom 13.

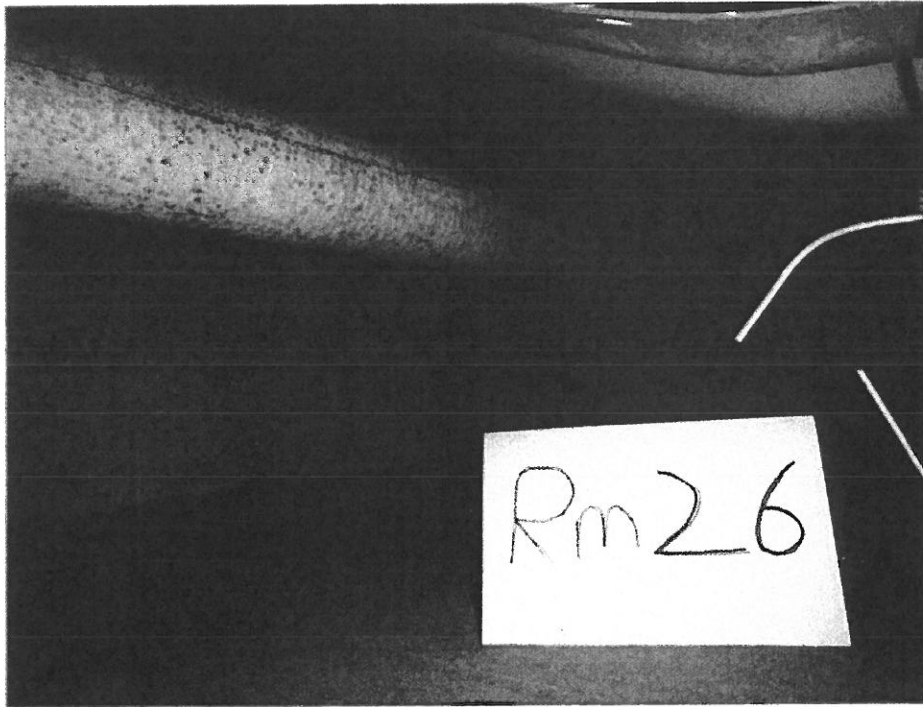
Photograph 1: Pipe insulation above ceiling in room 26 on August 30, 2013.

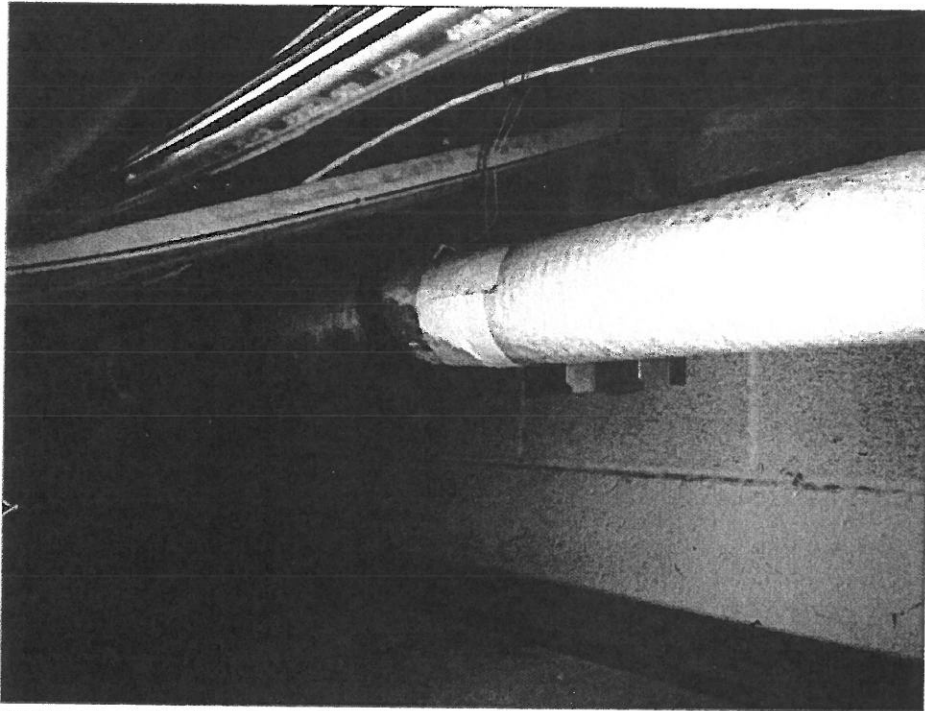
Photograph 3: Pipe insulation above ceiling in room 26 on August 30, 2013.

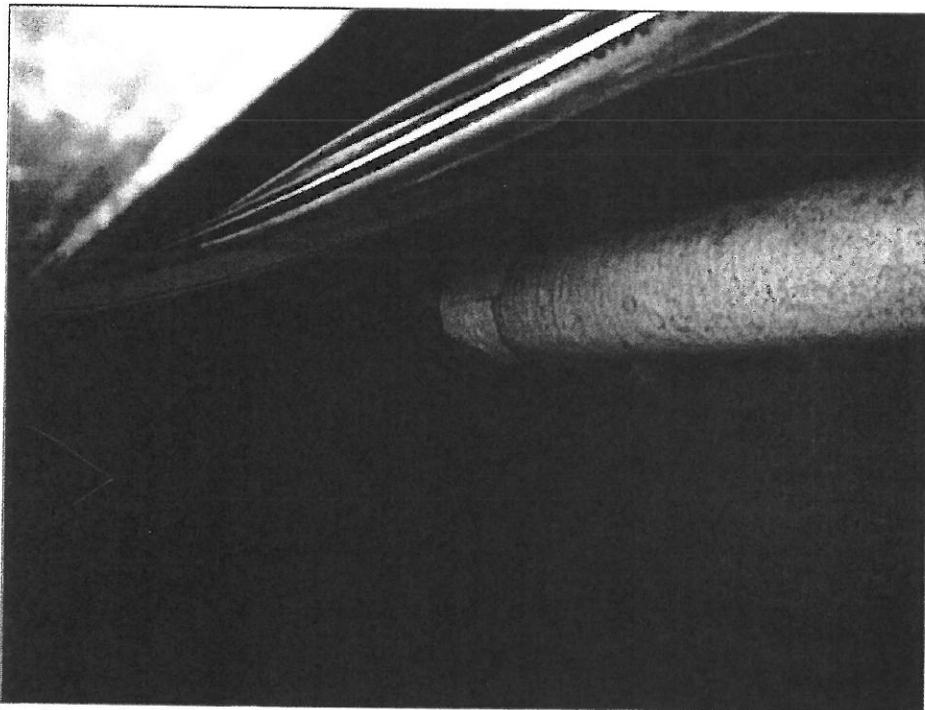
Photograph 4: Pipe insulation above ceiling in room 26 on October 18, 2013.

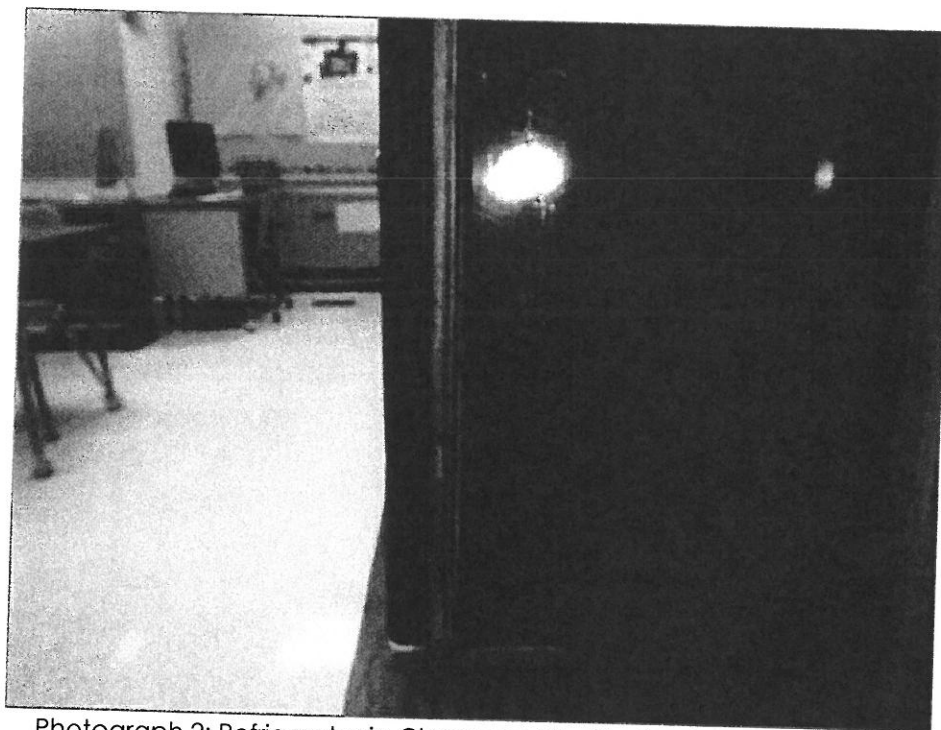
Photograph 2: Refrigerator in Classroom 15 with discoloration on door.

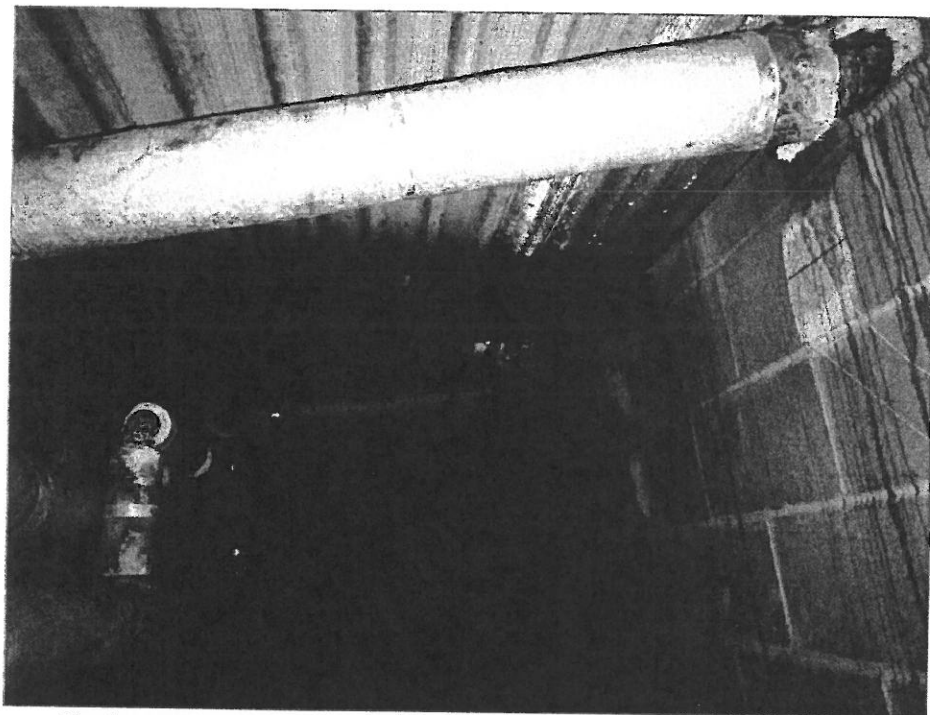
Photograph 8: Pipe insulation in crawlspace under Classroom 15.

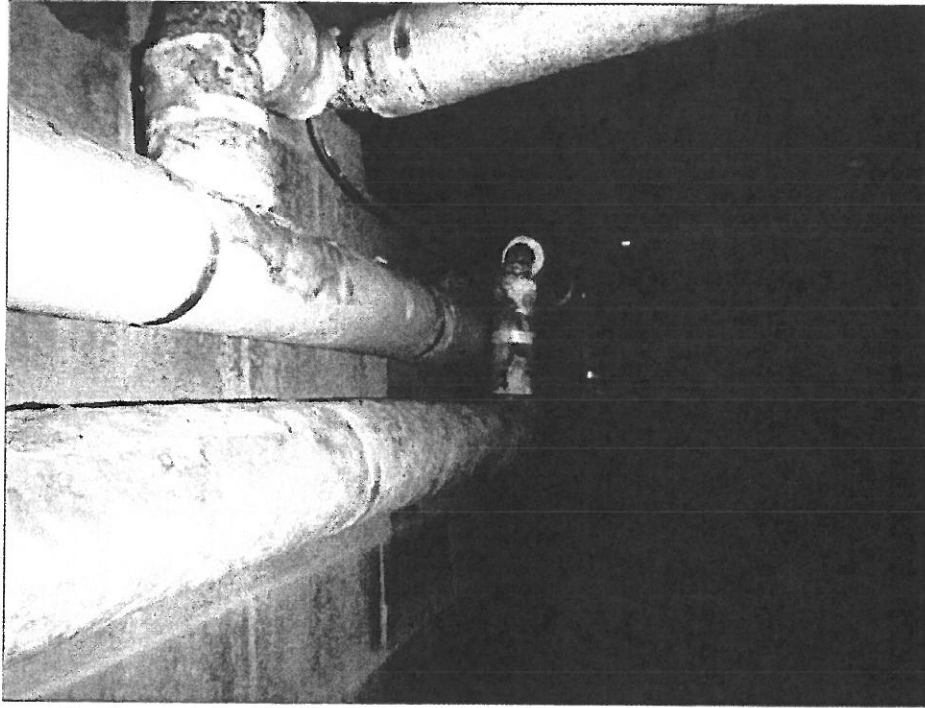
Photograph 9: Pipe insulation in crawlspace under Classroom 15.

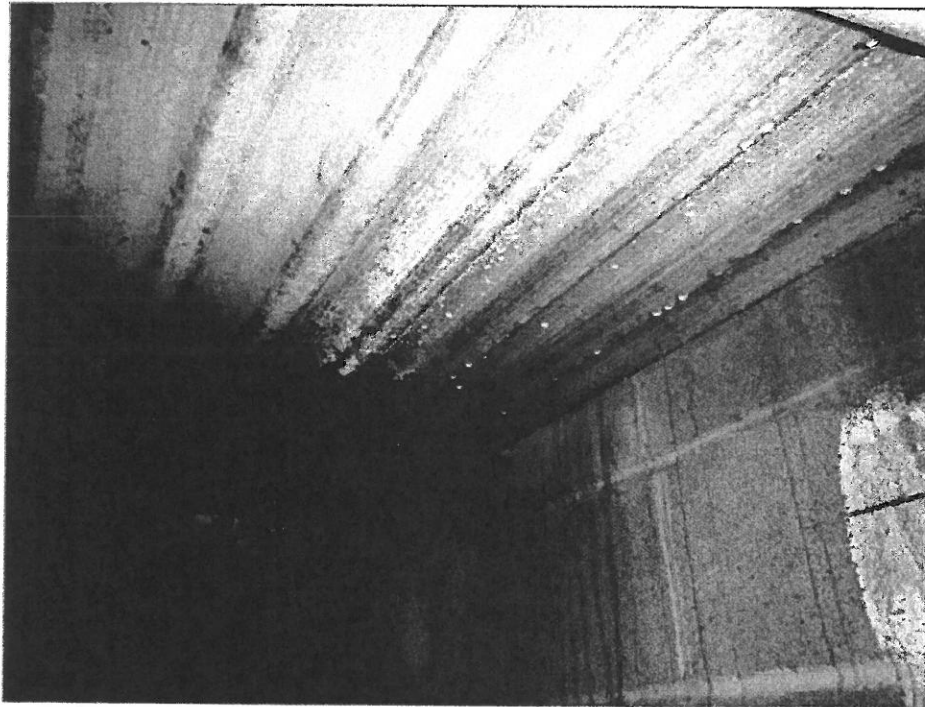
Photograph 10: Condensation on metal deck over crawlspace under Classroom 15.

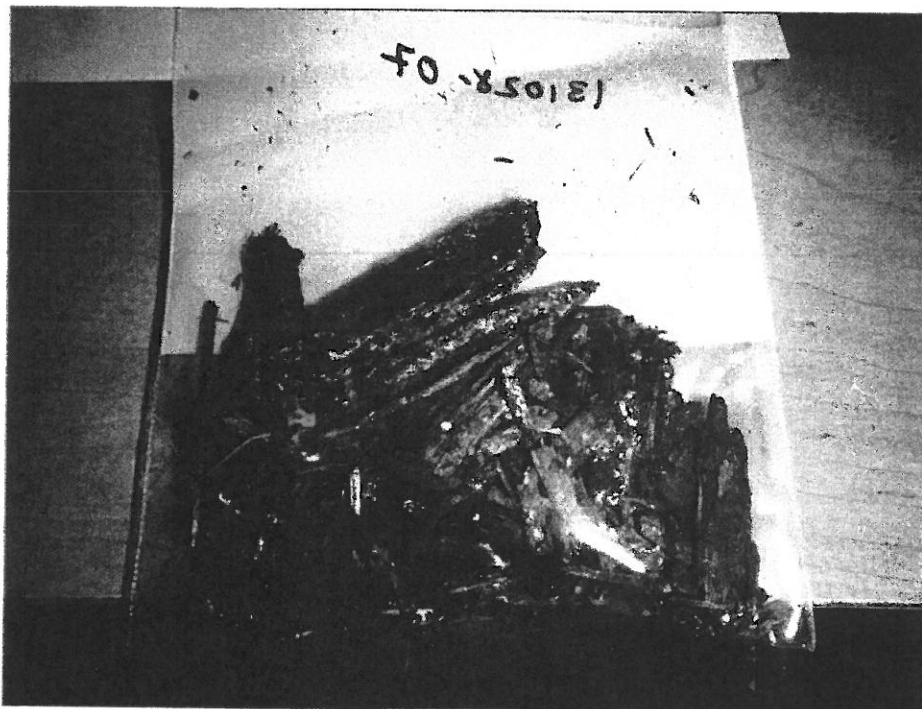
One bulk sample of mulch was collected at the air intake into classroom 15 through the uninvent. The sample revealed Basidiospores, brown unidentified spores, hyphal elements and the Smuts/Periconia/Myxomycetes group spores that are typical of plant decay. The mulch is not the source of increased *Penicillium*/*Aspergillus* group spores observed in the classroom.

Photograph 12: Mulch sample submitted for laboratory analysis from outside Classroom 15 near air intake to the Univent.
